Seed cleaner scores 100% buy again rating

Kondinin Group evaluated the DE Engineers seed cleaner based on a survey of 19 owners asking them to rate their seed cleaner's performance.

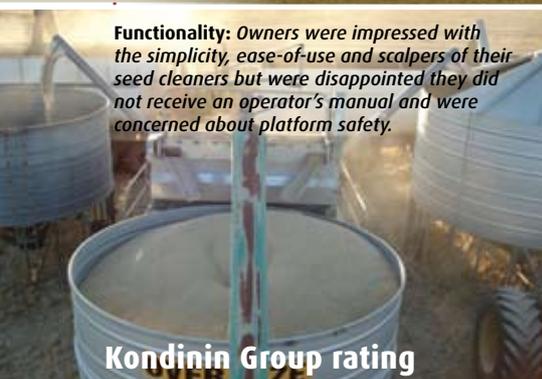
Photo: DE Engineers

Functionality: Owners were impressed with the simplicity, ease-of-use and scalpers of their seed cleaners but were disappointed they did not receive an operator's manual and were concerned about platform safety.

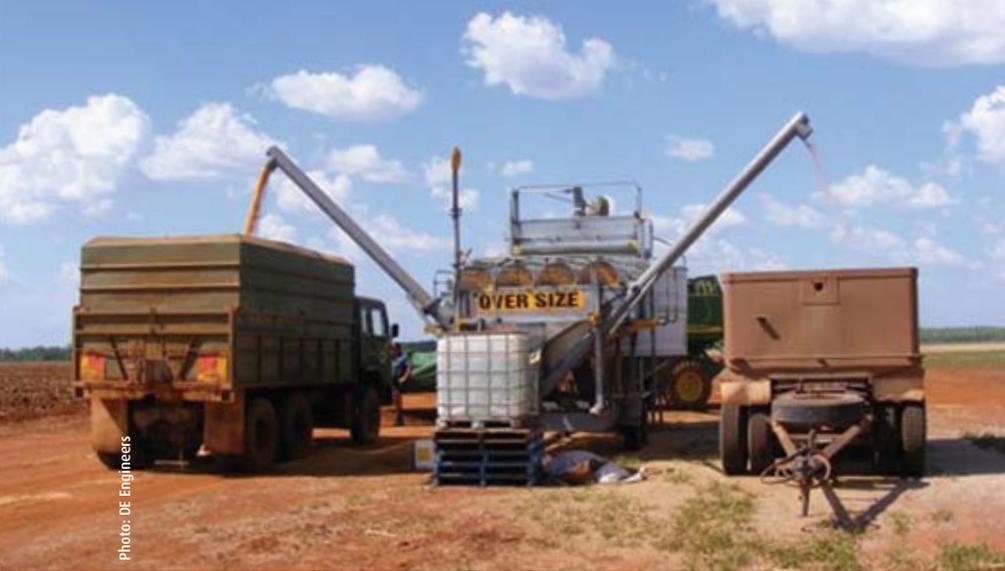
Photo: DE Engineers

Cleaning and moving: The units cleaning capacity pleased owners although some found the auger heavy and difficult to manoeuvre.

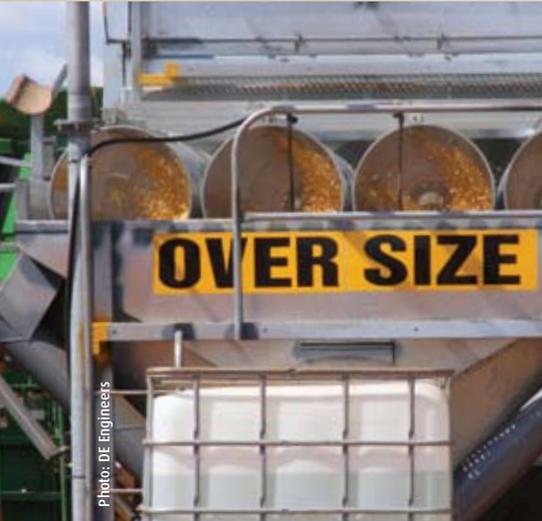
Owners were generally pleased with the cleaning quality of the unit (scoring it 81%), and the cleaning evenness (83%). A WA owner of a three-barrel unit said the seed cleaner worked only on material size, which caused problems removing rubbish, particularly from barley. Another WA owner of the same unit modified the diverter on the intake auger to provide a more even grain distribution.
